2016 Case Study

Asphalt & Epoxy Cast Iron Soil Pipe

Auger Test

NewAge Casting Pipe & Fittings vs. Competitor

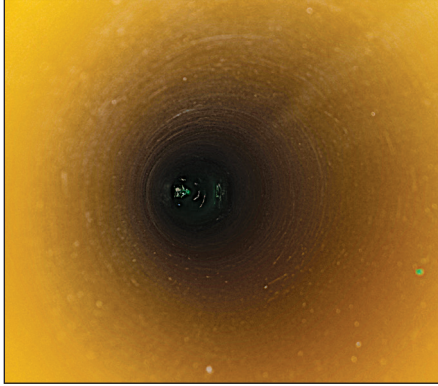
NewAge
Epoxy Pipe

The NewAge Epoxy 1/4 Bend had absolutely NO shavings after the auger test was completed. The Epoxy coating on both the pipe and fittings shows no damage with their coatings still intact.

The conclusion is really a question that each expert must ask: Given the better results of NewAge's products, what will you select for your future projects? Augering the epoxy coated pipe and fittings did not expose any raw cast iron.

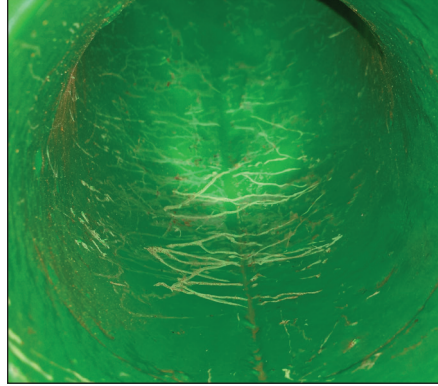
NewAge
Epoxy 1/4 Bend

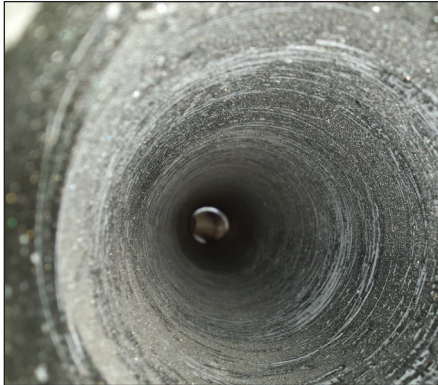
NewAge
Asphalt Pipe

As evidenced by these pictures, both brand's asphalt pipe and fittings had similar results. The NewAge Asphalt 1/4 Bend only had one-half teaspoon of shavings versus the full teaspoon of shavings from the competitor's asphalt coated 1/4 Bend.

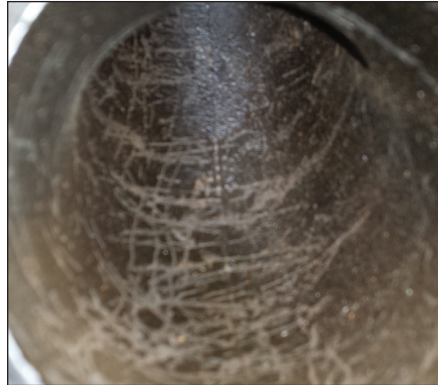
NewAge
Asphalt 1/4 Bend

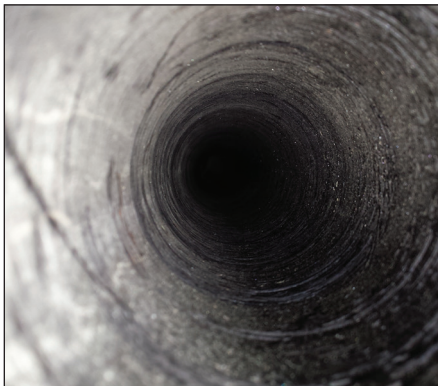
Competitor's
Asphalt Pipe

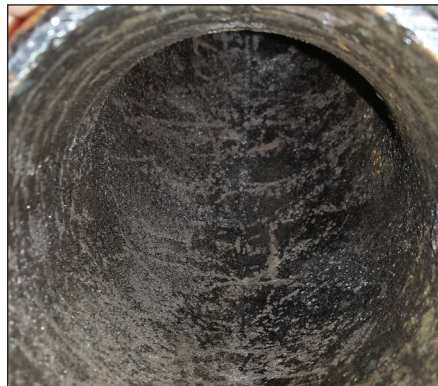
Competitor's
Asphalt 1/4 Bend
